An Independent View of the Pinheiros Station Accident (Sao Paulo Metro) and Lessons Learnt for Future Contractual Arrangements

J.M. Barros (IPT)

A.P. Assis (UnB)

ITA World Tunnel Congress, Agra, India – 19-25/09/2008

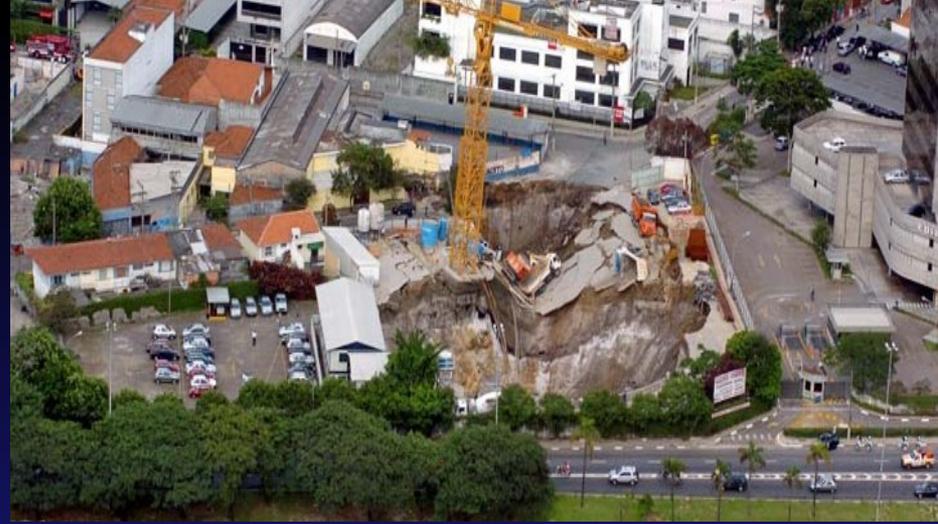
Introduction: Pinheiros Station Accident

- Occurred on 12/01/2007
- During the bench excavation, very close of arriving to the shaft
- First failure signs ~14h30
- Daylight collapse at 14h54
- **Enormous material damages and 7 fatalities**
- **IPT commissioned the technical investigation**

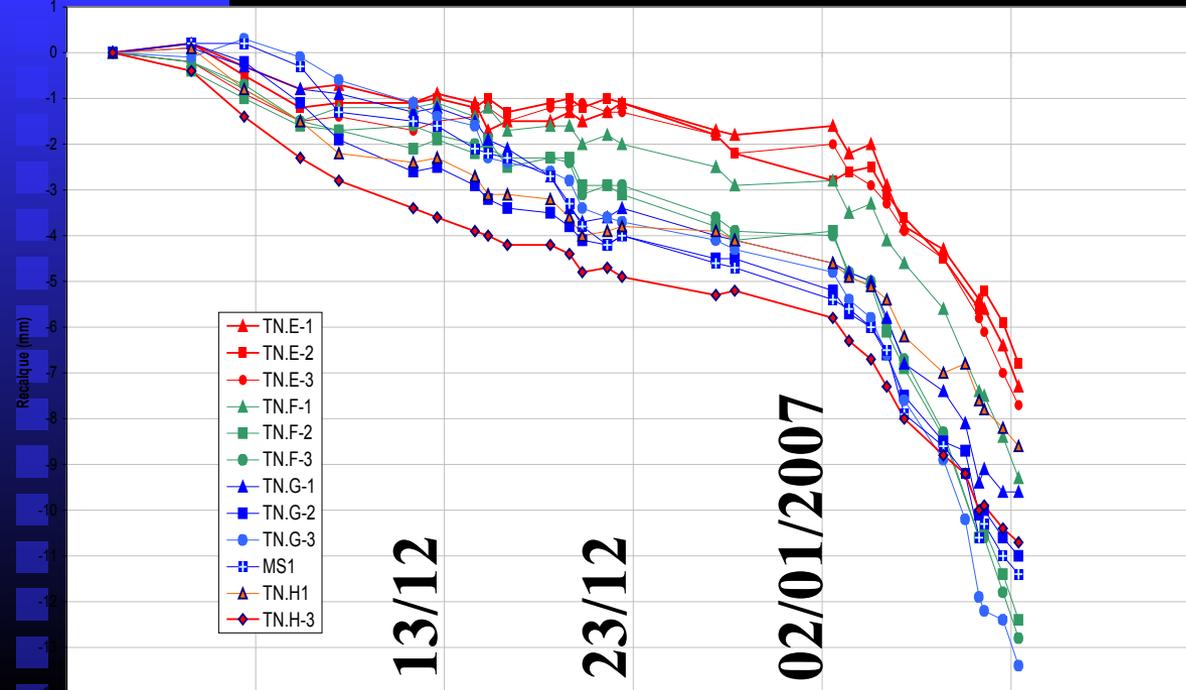
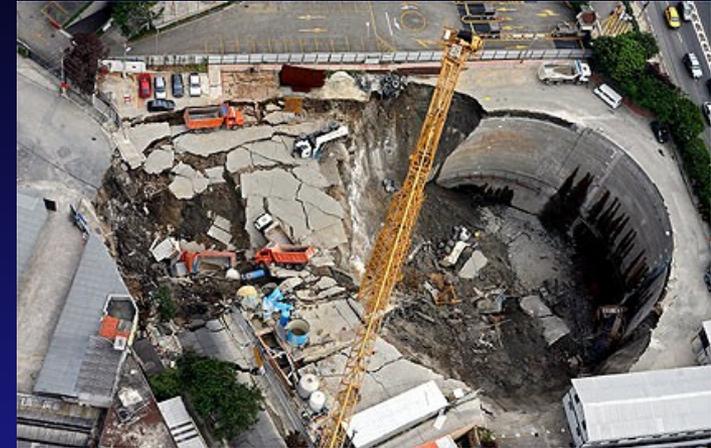
Collapse

Instrument	Position	Forecasted (mm)	Observed on 11/01/07 (mm)	Observed / Forecasted
Extensometer	Axis	-0,7	-11	17
	Lateral Wall	-0,7	-12	19
Convergence Pins (Settlement)	Axis	-0,7	-7	10
	Upper	-0,9	-20	22
	Lower	-0,5	-7	13
Convergence	△ P2-P3	-0,2	-21	95

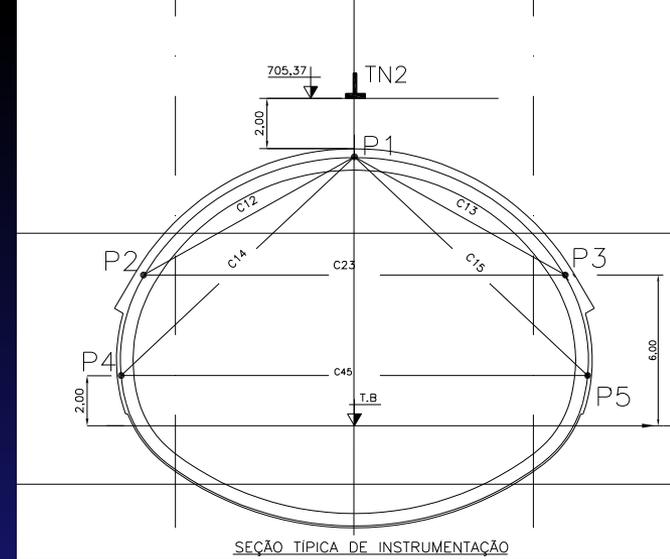
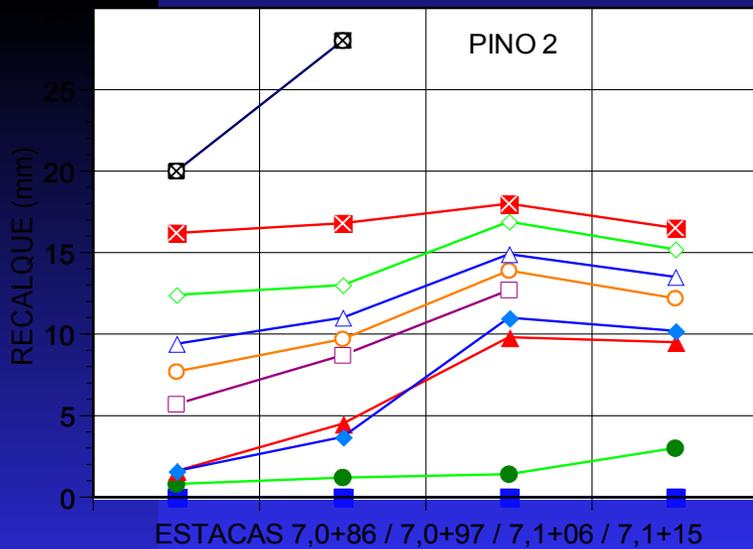
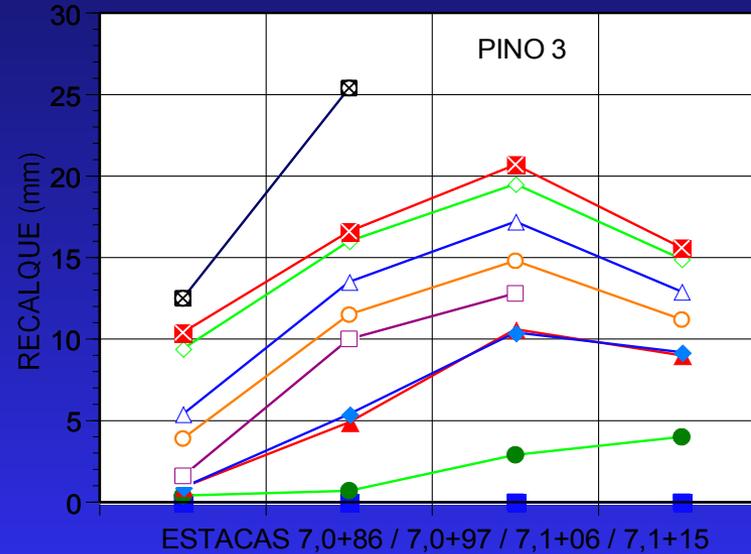
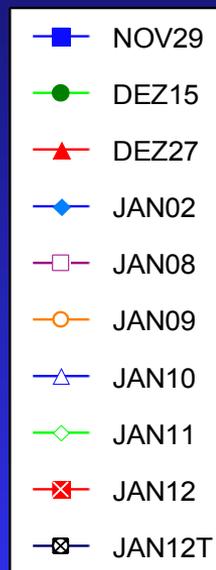
Main Report Findings: Collapse Evidences

Instrumentation evidences

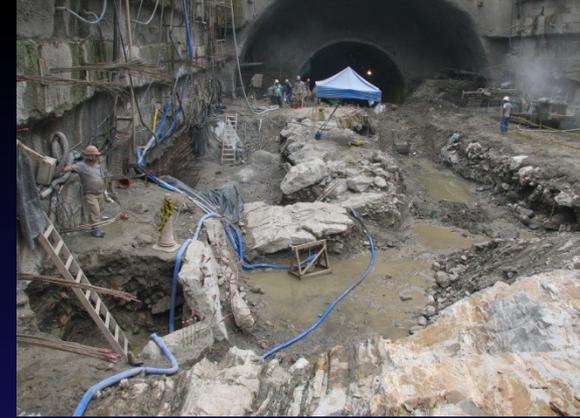
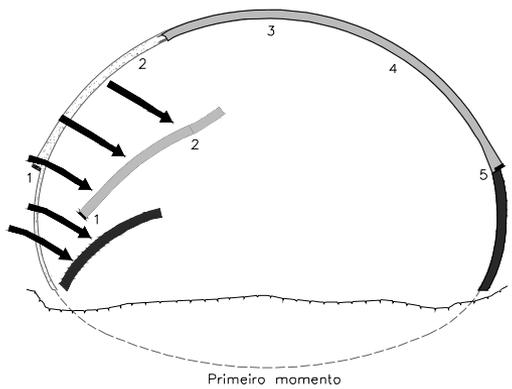
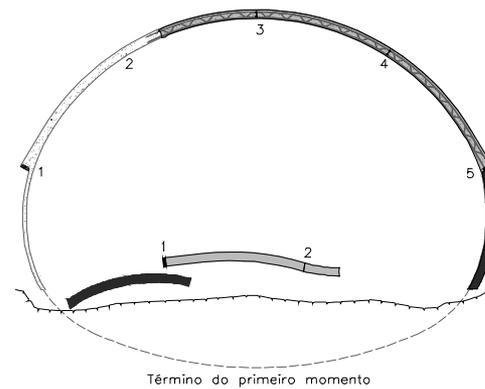
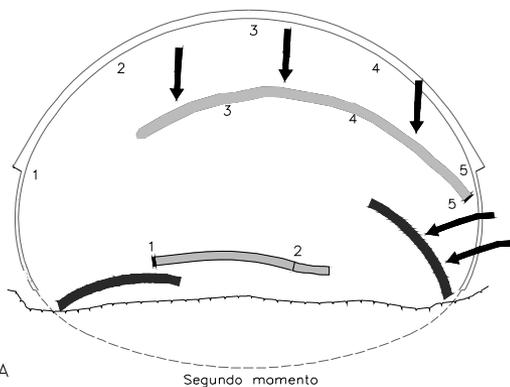
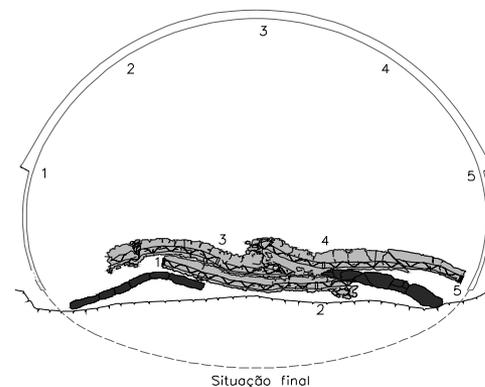
Main Report Findings: Collapse Evidences

■ Debris position evidences
