# Report on the Damaging Effects of Water on Tunnels During Their Working Life

## ITA Working Group on Maintenance and Repair of Underground Structures

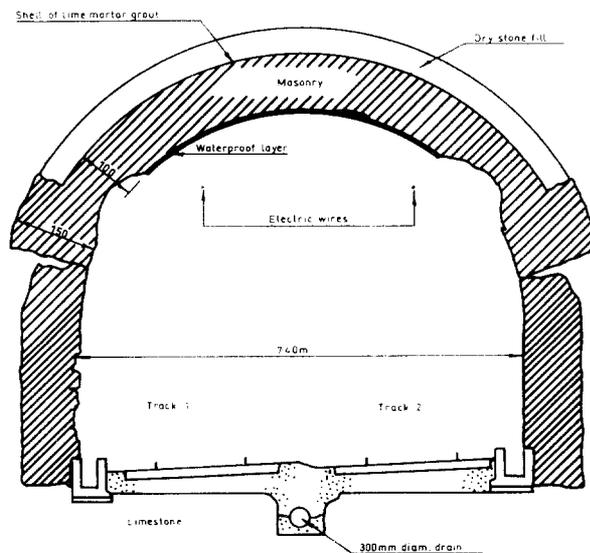
Fig. F2/1 PAGNY SUR MEUSE TUNNEL  
SITUATION BEFORE RENOVATION

NATURE OF INFLOW:	Considerable wetness in the whole structure.	
EFFECT(S) ON STRUCTURE OF TUNNEL:	<ul style="list-style-type: none"> <li>• Weathering of the masonry walls, particularly cracking and scaling of the facing rubblestones due to freezing.</li> <li>• Thinning of the vault lining, caused during the electrification, which could have long-term effects on the performance of this part of the structure.</li> <li>• In the crown, detaching of the waterproofing coat placed during the electrification works.</li> <li>• Failure of bonding in the masonry at the springings.</li> <li>• Partial dislodging of walls as a result of the works of lowering the track bed during electrification.</li> <li>• Mud, rising up through the track bed, which must be cleared away.</li> </ul>	
EFFECT(S) ON INSTALLATION IN TUNNEL:	None.	
METHOD(S) OF CORRECTION:	<ul style="list-style-type: none"> <li>• For the tunnel crown: <ul style="list-style-type: none"> <li>– Refurbishment of the blocking masonry through injection;</li> <li>– Filling of voids resulting from the thinning of the lining during electrification;</li> <li>– Provision of a reinforced shell of shotcrete (see Figs. F2/1-3).</li> </ul> </li> </ul>

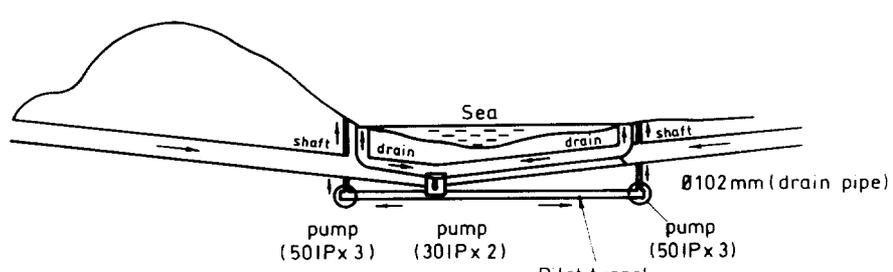
</div> <p>Fig. J1/1: Drain system for the Kanmon Tunnel</p>

EFFECT(S) ON STRUCTURE OF TUNNEL:	<ul style="list-style-type: none"> <li>• Concrete of the lining was neutralized in 10–40 mm depth in deteriorated concrete. The strength of the concrete was reduced.</li> <li>• Cracks are developing in the concrete track-slabs and cement asphalt mortar is deteriorating.</li> </ul>	
EFFECT(S) ON INSTALLATION IN TUNNEL:	<p>The leaked sea water is splashed, thereby forming a mist caused by the suction effect of trains. This results in the progressive erosion not only of the rails, but also of the electric facilities at the ceiling. The main salt-related damages due to water leakage are:</p> <ul style="list-style-type: none"> <li>• Rust-like pockmarks 1–1.5 mm deep are generated on the entire surface of the rails.</li> <li>• Fastenings and other attachments of rails are corroded progressively.</li> <li>• Salt water adheres to the insulator of the feeder line, ruining the insulation.</li> <li>• The lighting facilities are also ruined, e.g., through the corrosion of metals and demolition of lamps.,</li> <li>• Corrosion of stainless steel attaching bolts of the drain pipes.</li> <li>• Clogging of the drain pipes (drainage system is shown in Fig. J1/1).</li> </ul> <div style="text-align: center;">

JAPAN		CASE J1 (contd.)
<b>METHOD(S) OF CORRECTION:</b>	<p>A 10-year program of water leakage prevention measures has been carried out since 1979; 10740 m are being treated with cut-off works. The measures applied involve the placing of drain pipes and coating concrete linings with a sealing agent called Hydeck-K-11, which is composed of special permeable chemicals such as cement particles and resin emulsion. These compounds are mixed with water and coated on the concrete surface. After coating, these permeable compounds react with the isolated lime of the concrete to attain crystallization and, consequently, fill up the capillary void of the concrete, thereby resulting in a sealing effect.</p> <p>The rails are replaced every 5.8 years. Alloyed steel rails tentatively have been placed in the undersea section, and their effectiveness is being analyzed. For other materials, corrosion prevention measures such as replacing and cleaning of the fastening devices are carried out. A periodic coating of silicon resin is applied to the insulator, and titanium alloyed bolts for the drain pipe attachments are employed as well.</p> <p>A summary of the maintenance costs over a 10-year period is shown in Table J1/2, below.</p>

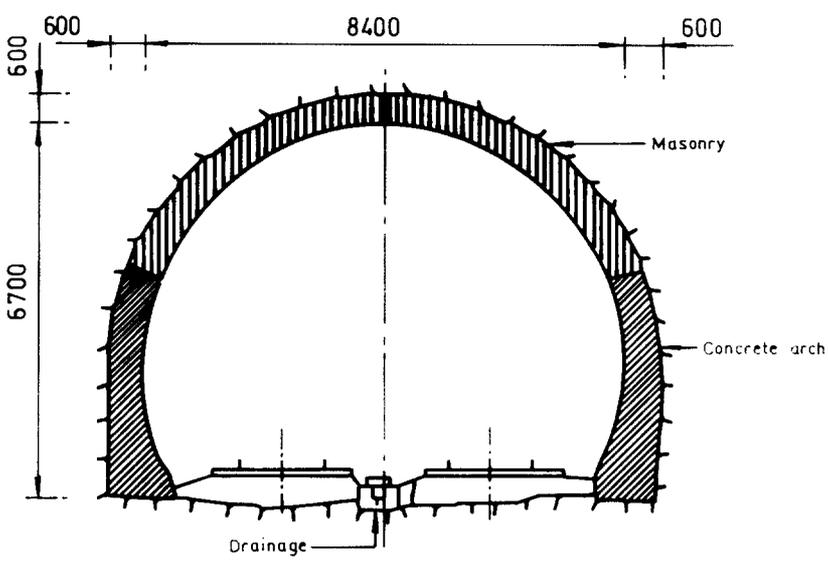
<p style="text-align: center;">Fig. CH3/1: Cross-section of the Hauenstein - Basistunnel before repair</p>	
<b>NATURE OF LINING:</b>	The crown lining consists of masonry, the side walls and abutment of concrete; average thickness ca. 0.6 m.	
<b>GEOLOGICAL AND HYDROLOGICAL CONDITIONS:</b>	The north and south part of the tunnel were excavated in hardly water-permeable, marly clay soil with swelling characteristics (swelling pressure 20–200 N/sq. cm). The middle part of the tunnel was constructed in water-permeable, limey marly soil (water inflow during the construction period ca. 30 l/s; water temperature 28°C).	
<b>NATURE OF INFLOW:</b>	Considerable wetness in the whole structure; wetness in the invert; water has somewhat high concentrations of lime and sulfate.

<b>EFFECT(S) ON STRUCTURE OF TUNNEL:</b>	<ul style="list-style-type: none"> <li>• Drainage defect, because of lime sedimentation and swelling soil.</li> <li>• Clearance height reduced, because swelling soil lifts rails.</li> <li>• Mud rising up through the track bed.</li> </ul>

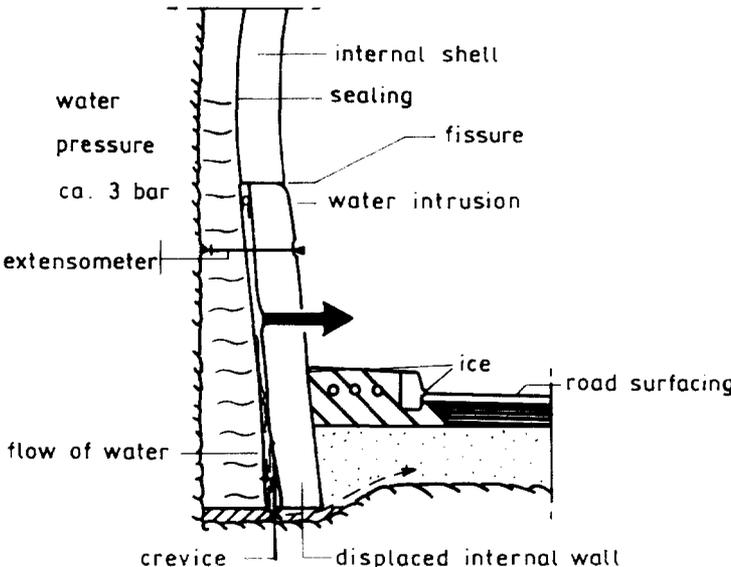
<b>EFFECT(S) ON STRUCTURE OF TUNNEL:</b>	Fissures in the internal shell.	
<b>EFFECT(S) ON INSTALLATION IN TUNNEL:</b>	Icy road and escape route.

Fig. CH4/1: Water leakage in the Rofla-Tunnel
