TBM EXCAVATION OF LONG AND DEEP TUNNELS UNDER DIFFICULT ROCK CONDITIONS

ITA Working Group n°17
Long Tunnels at Great Depth

ITA REPORT N°19 / MAY 2017

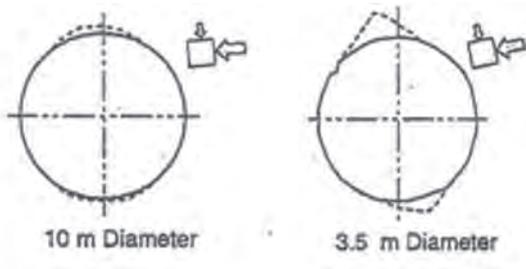
<div style="margin-left: 20px;"> <p><i>Figure 1. Comparison of the failed areas for tunnels of different size and shape and corresponding orientation of the in-plane in-situ principal stresses [3].</i></p> </div> </div> <p>This hazard is mainly observed at the tunnel crown or at the side walls (Fig. 2). Rockburst may also happen at the face, leading thus to a blocky face (Fig. 3).</p> <p>Rockburst mostly happens approximately 0 to 2 diameters behind the face, and some hours after the front excavation, and stops when the surrounding rock mass has found a new equilibrium based on the prevailing stress conditions. This phenomena is also known as "strainburst".</p> <p>Rockburst can also happen unexpectedly at any time, in a greater distance from the tunnel face, due to unpredictable stress redistribution (induced e.g. by surrounding excavations, seismic event, etc...).</p> <p>Brittle rock behaviour has different qualification regarding the intensity level:</p> <ul style="list-style-type: none"> • Spalling (low intensity). Failure of the rockmass without projection of materials (so-called onion skin or scaling); • Rockburst (high intensity). Failure of the rockmass characterized by a violent and sudden release of energy with shooting/projection of pieces of rock. In the extreme case, the rockburst may lead to a complete collapse of the tunnel. <p>The occurrence of such problems may lead to damage of the machine and/or injure the workers. Moreover, the occurrence of rock-burst may lead to a blocky much which may case difficulties in the mucking-out operations.</p>

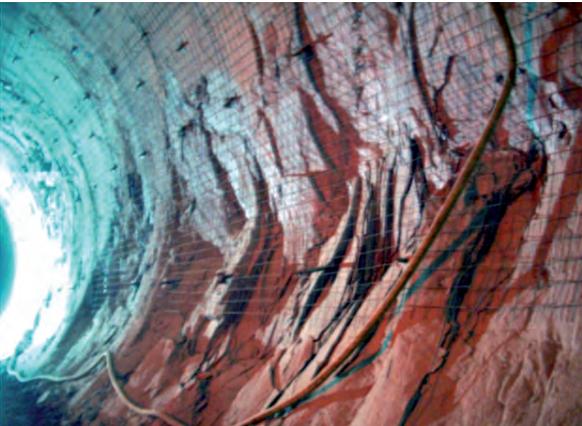
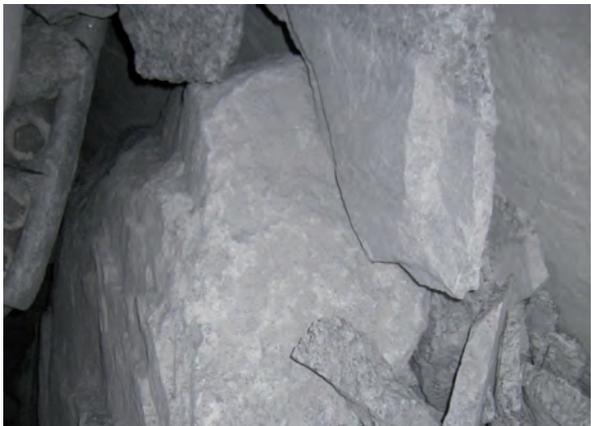
</div> <p><i>Figure 2. Rock spalling in the Aare granite during the construction of the Lötschberg Base tunnel.</i></p> <p><i>Figure 3. Blocky face observed after rock-burst (Gotthard Base tunnel).</i></p>

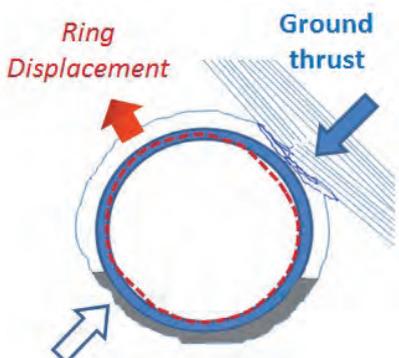
<p><i>Figure 4. Buckling occurring on the upper right (and bottom left) side wall [8].</i></p> <p>The occurrence of buckling may lead to long standstills, particularly when hand-mining works are necessary</p>

BUCKLING	
<p>Definition</p>	<p>Rupture of the rock along the direction of the foliation or bedding planes leading to bending of the foliation towards the opening (Fig. 4).</p> <p>This phenomenon is mainly observed in tunnels excavated parallel to the foliation direction and it occurs in the proximity of the tunnel face. Buckling is particularly intense when the in-situ stress is parallel to the foliation direction. The consequence of buckling is a highly anisotropic deformation of the excavation profile (convergence perpendicular to the foliation much higher than parallel to it) and consequently a strong asymmetrical load on the support (e.g. ribs, shotcrete, see Fig. 5) and on the final lining (e.g. segmental lining), respectively.</p>

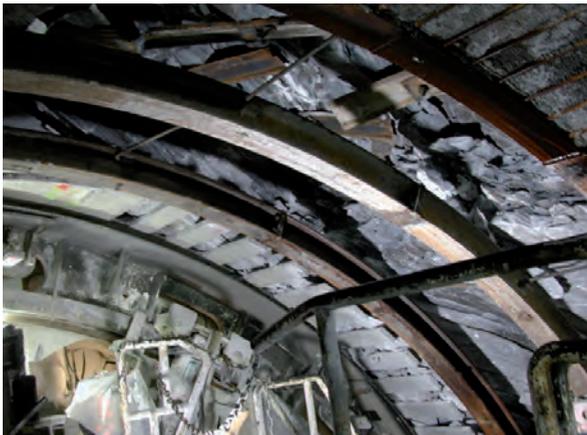
<p><i>Figure 5a. Consequences of buckling on ribs and shotcrete support (Loetschberg base tunnel).</i></p>

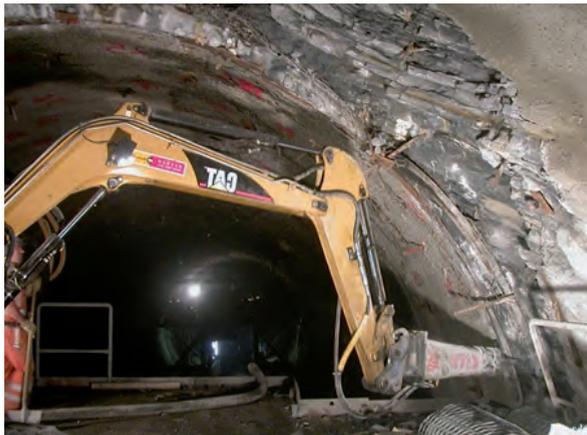
<p><i>Figure 5b. Consequences of buckling on ribs and shotcrete support : reexcavation before final lining.</i></p>

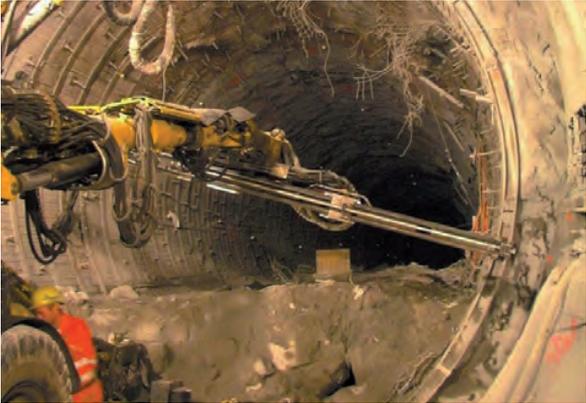
<p>Figure 6. Tunnel convergence due to highly intense squeezing – Gotthard tunnel conventional drive (Sedrun) [15].</p> </div> <div style="text-align: center;">

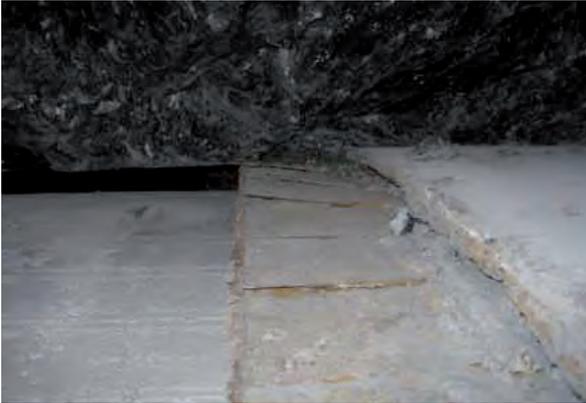
<p>Figure 7. Single shielded TBM jammed in squeezing ground (Uluabat Tunnel; Figure courtesy of Werner Burger, Herrenknecht AG).</p> </div> </div>

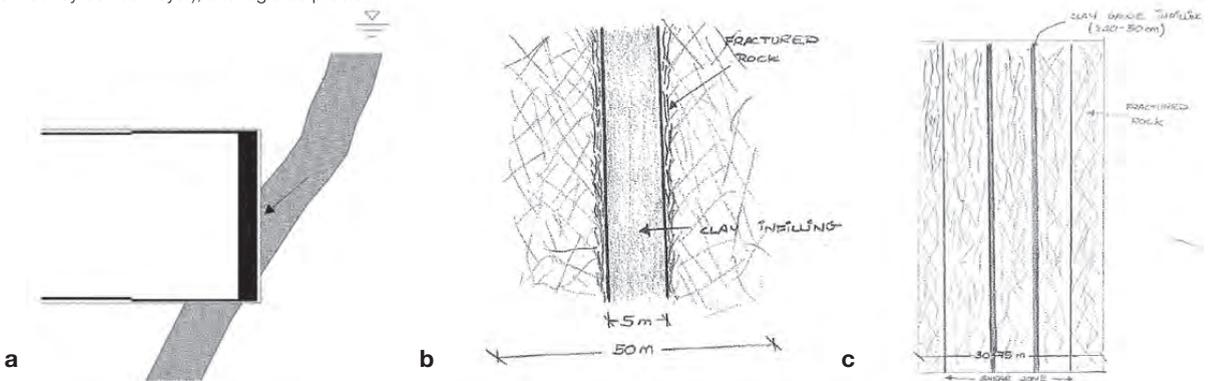
<p>Figure 8. (a) Water and fines inrush and trapped water in (b) open dykes or (c) clay layers.</p>
Predictability	POSSIBLE TO PREDICT to DIFFICULT TO PREDICT (e.g. in karstic rock)
Rock conditions	<ul style="list-style-type: none"> • Water bearing rock mass • High permeability rock mass • (High recharge potential)

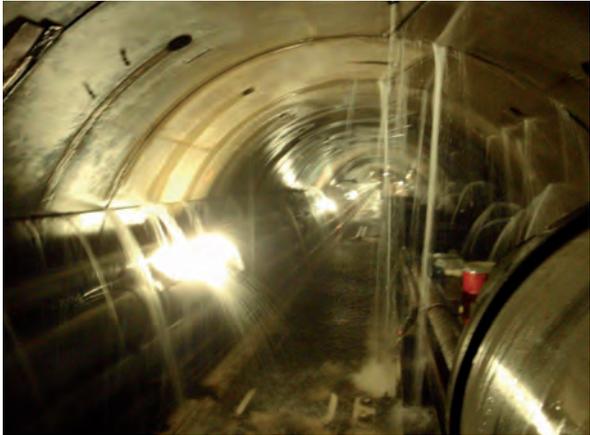
<p>Figure 9. Water inflow observed during the construction of Salazie Aval (Figure courtesy of JV RAZEL-BEC).</p>

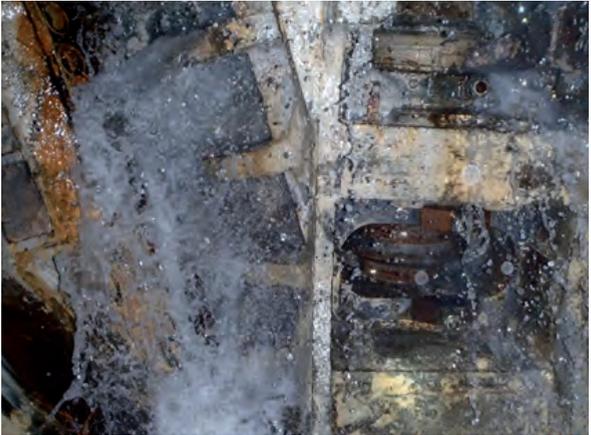
<p>Figure 10. Water inflow observed during the construction of the Lake Mead Intake No. 3 tunnel (Figure courtesy of JV Impregilo-Salini-Healy, USA).</p>

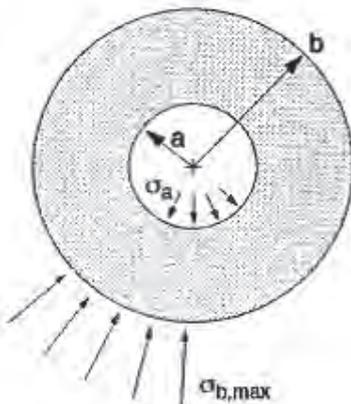
<p>Figure 11. Water pressure acting on the grouted rock mass [10].</p>

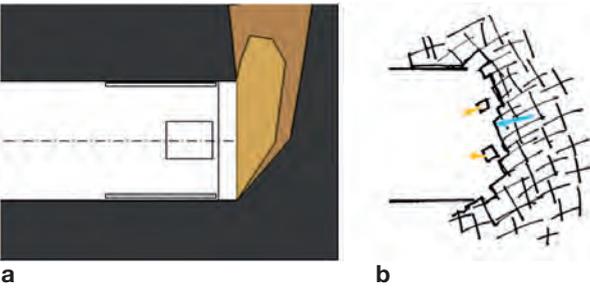
<p>Figure 12. (a) Major tunnel face instability and (b) local face instability under high water pressure ("pop-rock").</p>
Predictability	DIFFICULT TO PREDICT
Rock conditions	<ul style="list-style-type: none"> • Low strength ground or blocky rock mass (typically fault or hydrothermally altered zones) • (High water gradients) • (for face instability induced by rockburst see §2.1.1)
Phenomena

FACE INSTABILITY	
Definition	<p>Instability of the rock mass at the tunnel face (Fig. 12a). The tunnel face instability may be induced by the singular or simultaneous occurrence of poor rock quality, high stress level, high water pressure and unfavourable orientation of the discontinuities:</p> <ul style="list-style-type: none"> • Poor rock quality. Low strength rock masses are typically faults or hydrothermally altered zones (e.g. sandy fault zones, clayey fault zones, blocky rock mass, ...). The tunnel face may become unstable because of an insufficient bearing capacity of the ground. • High water pressure. Deep tunnels located below the water table are often characterized by high water pressure (and so high destabilizing seepage forces) that may induce face instability (even of cemented rock mass). The high water pressure increases also the intensity of local instabilities: rock pieces may be projected from the tunnel face, thus making even face inspections dangerous (cf. Fig. 12b). Finally, water pressure may cause punching type failures, when acting on low permeability rock layers. • Rockburst. Sudden and explosive failure of the face, causing damage to the cutterhead and cutters; can lead to sudden blockage of the cutterhead. • Squeezing. Intense squeezing phenomenon leads to large plastic extrusion of the tunnel face, and in extreme cases to a face collapse. • Unfavourable discontinuity orientation. The TBM advance in rock mass characterized by closely spaced discontinuity planes running perpendicular/sub-perpendicular to the tunnel axis is unfavorable because of the formation of a blocky muck (i.e. no chips); the cutting action of the discs produces the formation of unstable wedges that slide from the tunnel face. This may cause the damage of the cutterhead, cutters, buckets and belt conveyor. <p>In TBM tunnelling, the occurrence of major face instability causes blocking and possibly damaging of the cutterhead (Fig. 13).</p>

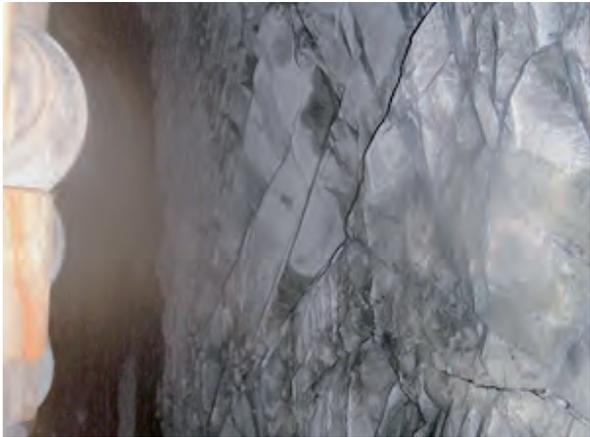
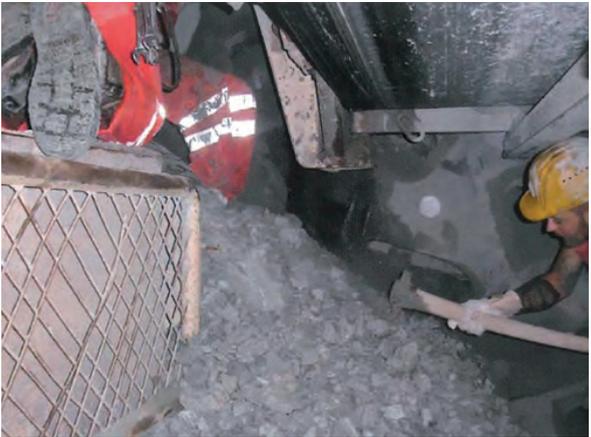
<p>Figure 13a. Blocky face due to high stress level (Lotschberg Base tunnel).</p> <p>Figure 13b. TBM blocked due to a major face instability (Gotthard Base tunnel [1]).</p>

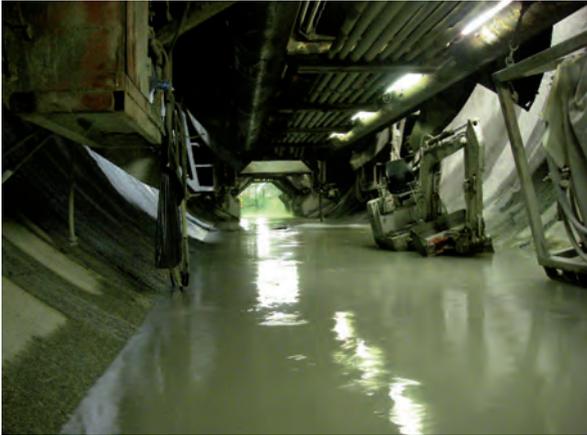
<p>Figure 14. High hot water ingress (43°C) at the Gotthard Base Tunnel.</p>

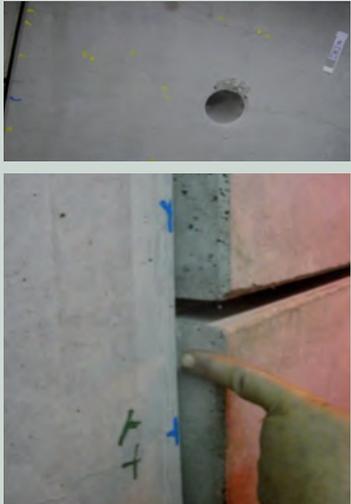
<p>The issue of the ring stabilization was improved by the following modified annular void filling sequence in order to create an abutment and the setting of the ring:</p> <ul style="list-style-type: none"> • mortar at the invert immediately during TBM progress; • pea gravel on the sides since ring N-2; • mortar at the crown from ring N-5 to ring N-7.

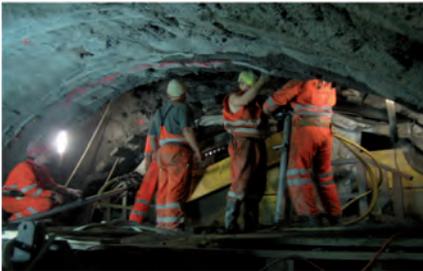
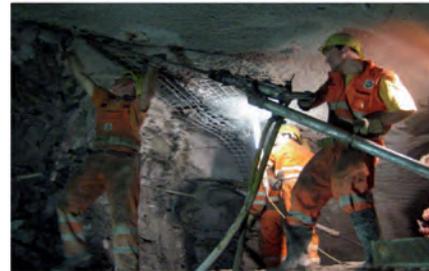
Lot Bodio, Western TBM:
The TBM got stuck after entering into the Lucomagno Gneiss, a formation which had not been expected in the Bodio lot, and which showed increased tendency for squeezing. The Eastern TBM managed to work through the zone with high thrust forces, while the Western TBM got stuck even with applying the maximum available thrust force.

The Western TBM was freed by overmining the crown shield, which took 10 days; with the freed crown shield the TBM could be moved; the mined space in the crown was subsequently filled with shotcrete

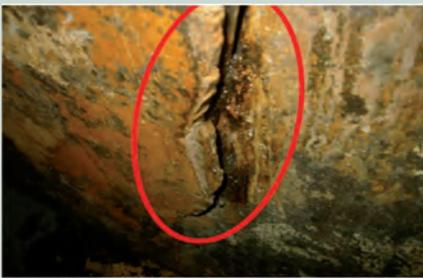
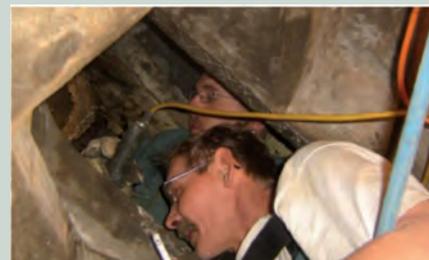
Lot Bodio, both TBM's:
The invert shield segments of both TBM's were severely damaged by trying to push the TBM through the squeezing zones.

Both TBM's needed in-situ repair of the invert shield segment, which was realized by excavating a small channel in the invert to create space for the welders

Continuous mining was adopted for both TBM's, splitting the on maintenance shift into short intervals to keep the TBM moving constantly

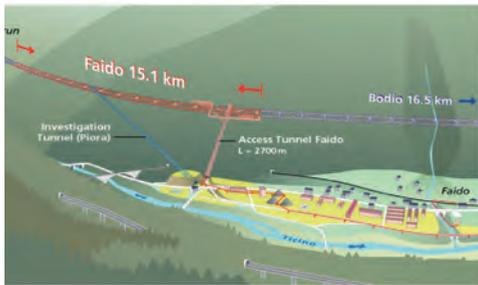
The Pióra zone, containing sugar dolomite under high water pressure, was explored with an adit tunnel approx. 300m above the base tunnel alignment. High water pressure was encountered. Probe drillings to base tunnel level encountered stable marble without water. Preventer-protected drillings were planned to check the zone which extended for approx. 140m.

During two years prior to the start, a working group of client/engineer and contractor worked together with specialists to develop core and percussion drill preventers suitable to be used on TBM's. The preventers were designed to withstand a water pressure of 200bar, and were tested in the start caverns of the TBM's prior to departure. The Eastern TBM was first to reach the Pióra influence zone, and was stopped 100m short of the presumed rock interface.

A 280m long core drilling was executed under preventer protection to explore the rock section containing the Pióra zone. The drilling was stopped when it reached the Medelser Granite on the far side of the Pióra marble. No water or squeezing phenomena were detected, and the TBM's passed the zone without difficulty. Duration of the campaign: 3 weeks (drilling 10 days)

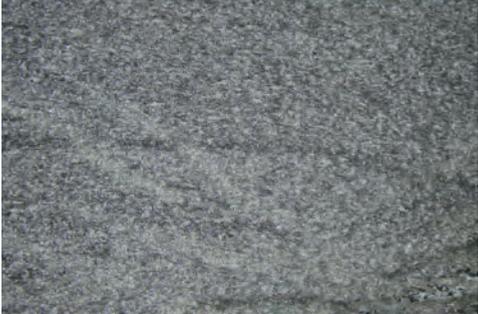
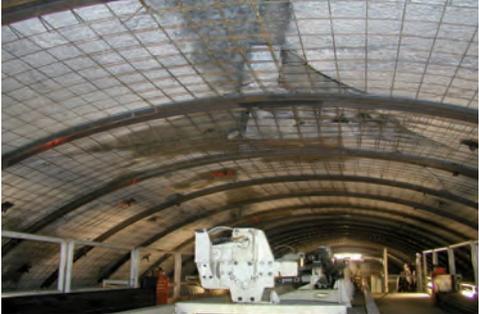
GOTTHARD BASE TUNNEL - LOT FAIDO	
CONSTRUCTION EXPERIENCE	
Observations	Solutions & consequences
<p>Lot Faido, both TBM's: Spalling occurred as soon as the TBM's entered the undisturbed Medelser Gneiss, and continued throughout the granite sections. Spalling was mainly observed at the 11:00h and 05:00h positions, perpendicular to the main stress distribution.</p>	<p>When spalling occurred, the risk for rockburst was rated high, and previously designed rock support was installed for:</p> <p>a) <i>low to medium rockburst:</i></p> <ul style="list-style-type: none"> • Yielding Swellex/Super Swellex Anchors, l = 3,9m • Wire mesh 2 x 5m, 10cm x 10cm mesh width • Overlap of wire mesh min. 20cm • Anchors positioned on overlaps of wire mesh • Head protection U-shaped beams in crown approx. 90° <p>Measures to be carried out over min. 180°, better 270° to protect personnel working in invert</p> <p>Advance rates 2m/hour</p>

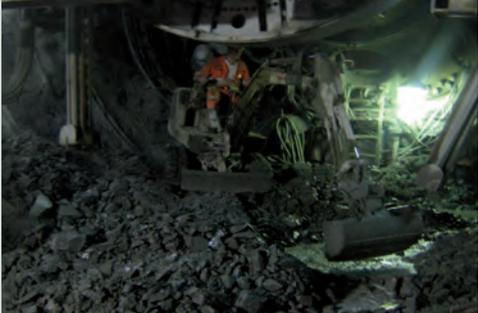
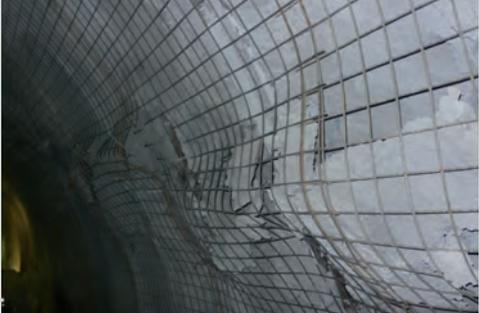
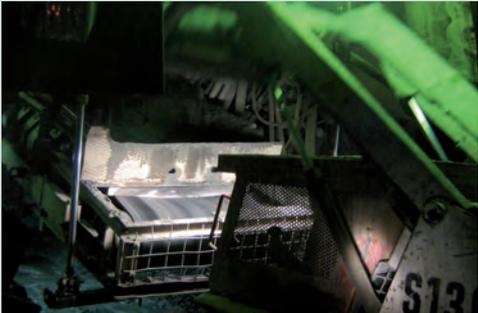
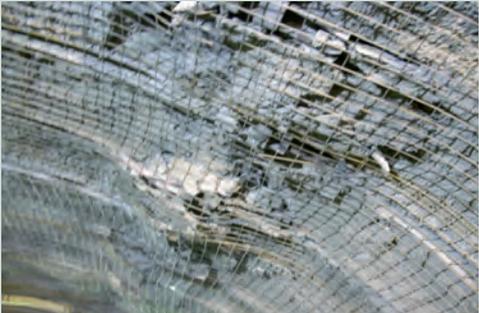
<p>A lot of loose material fell to the ground behind the shield and covered the invert. Cleaning works were improved by using bobcats as loaders. The secondary belt conveyor was modified to be lowered during standstills (maintenance shift etc.) so that the rock material could be loaded directly.</p>	<p>b) <i>strong to extensive rockburst:</i></p> <p>TH-type flexible ring beams (ring building times less than 30 minutes achievable)</p> <ul style="list-style-type: none"> • Wire mesh 2 x 5m, 10cm x 10cm mesh width • Overlap of wire mesh min. 20cm • Shotcrete min. 15cm • Second layer of wire mesh for head protection <p>If necessary radial pressure relief holes with large diameter</p> <p>Measures to be carried out over 360°</p> <p>Advance rates up to 1m/hour</p>

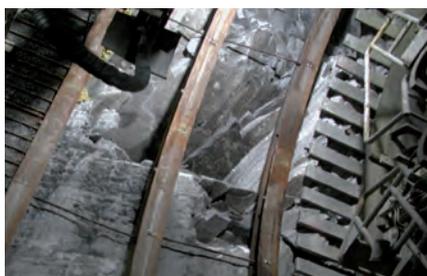
Buckling in foliated limestone due to unfavourable orientation. In middle orientation the excavation gave no problem, but in direction severe buckling occurred and the TBM was near to be blocked. The advance fall to 54m/ per month. The east tunnel (Raron drive) was bored in parallel with a D+B tunnel on 4.5 km. On the other tube (conventional excavation) the management of the buckling was easier.

The support was performed with HEB 180 steel girder every m'. Concrete was poured between the steel girder directly after installation. Additional Swellex were installed to allow the concreting operation. 3 years after the convergence perpendicular to foliation was 60 cm. A 200m section was reexcavated before installation of the permanent concrete lining.

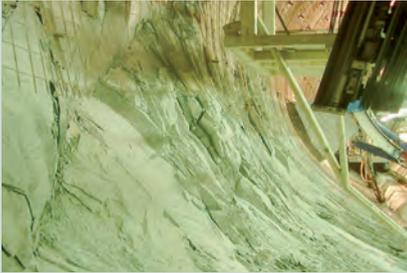
Vertical stress induced spalling on walls due to high overburden. In extreme falls no cutters marks were visible on the face.

Adaptation of the position of the anchors. Use of yielding swellex. Prediction of risk for the second drive based on the observations done on the first TBM drive

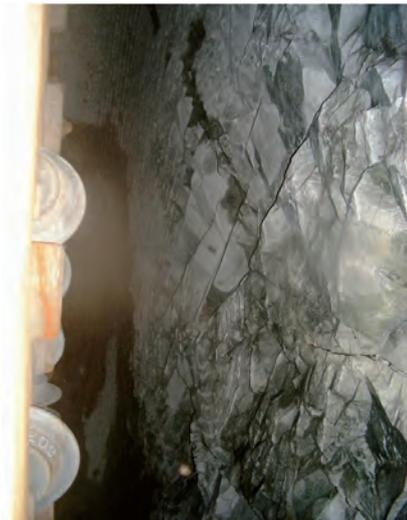
Tunnel face without any mark of disc cutter

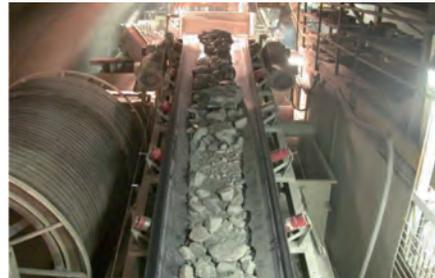
Blocks on band conveyor during boring

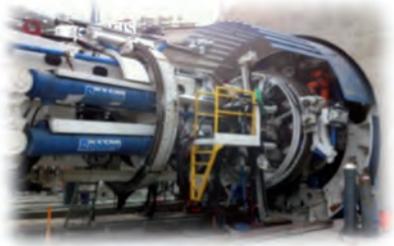
LA MADDALENA EXPLORATORY TUNNEL			
TBM DESIGN DATA			
TBM specific design	Open type TBM The peculiarities of the machine allow: <ul style="list-style-type: none"> • high feed rates in the presence of hard rock, thanks to the high installed power • operate forward probing of medium length, ahead of TBM • install bolts a short distance from the front • ensure the immediate support of the roof in presence of poor soils with installation of panels • launch medium-long boreholes which will be detecte and investigate geological structures

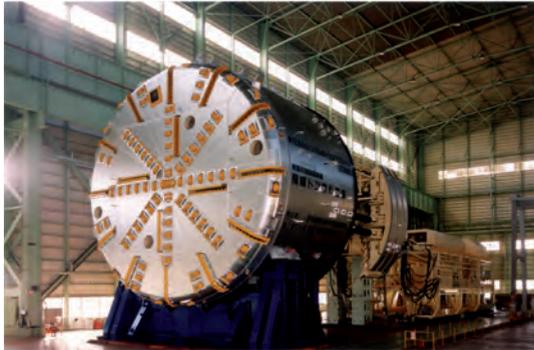
<p>Improved open-type Excavation diameter Ø 12.84m Machine length 19.5m Machine weight 310tons</p>

Shield Characteristics		Cutterhead	
Shield Length	19,5 m	Nominal cutterhead diameter	12,84 m
Maximal shield diameter	12,84 m	Maximal cutterhead diameter (overcut on diameter)	-
Minimal shield diameter	12,84 m	Number (excl. gauge cutters) and Diameter of cutterdisks	Center : 4nos, Inner : 77nos, gauge : 3 nos 19i nch
Shield conicity on the diameter	-	Total Power	4250 KW
Nominal top void	50 mm	Maximal Torque	31,84 MNm
Maximal top void	100 mm	Torque at maximal speed	-
		Breakaway Torque	10,14 MNm
Thrust			
Total Breakaway Thrust	33,7 MN	Nb of Grippers	2
Total Service Thrust		Grippers Thrust	44 100 kN
Number of Thrust jacks	6	Stress Thrust	2,45 Mpa shoe pressure
		Auxiliary Thrust	2 943 × 6 kN for friction cut

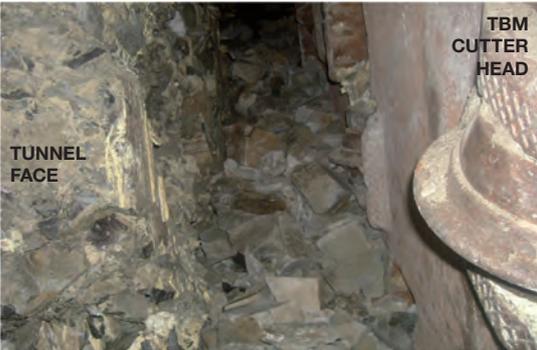
<p>The photograph shows the tunnel face on the left, characterized by a dome-shaped rock structure. On the right, the TBM cutter head is visible, with the labels 'TBM CUTTER HEAD' and 'TUNNEL FACE' overlaid on the image.</p>		<p>The forepillings have been applied in the zones where the joint density is large. Though the large strain has been generated in front of face in the zones where the forepiling has been adopted, it is shown quantitatively that the stability of face has been secured by the effect of the grout injection.</p>

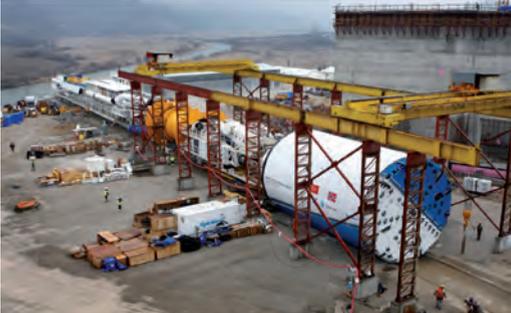
KARGI			
TBM DESIGN DATA			
TBM specific design	<p>For the initial TBM plan it was foreseen segment lining for weak sections roughly some 3,2 km at outlet side (km:11+872 -km:8+600). For last section between Km 0+000 to km:8+600 TBM planned to work with grippers only like hard rock TBM utilizing shotcrete and conventional supports such as bolts, mesh etc. where required.</p> <p>Due to problems encountered in TBM tunneling construction plan changed. In addition to modifications to TBM to cope actual conditions properly, another conventional attack face from inlet side employed to improve tunneling rates.</p> <p>Additional studies and expertise works carried out by owner and contractor for identification of problems and plan counter measures / preventions and to organize remedial works. Finally power tunnel constructed as;</p> <ul style="list-style-type: none"> • km:0+000 to km:4+003 conventional method • km:4+003 to km:11+872 TBM (all with precast segments, gripper never used)

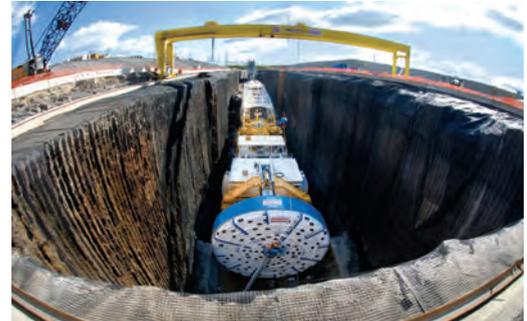
For the construction of the Niagara Tunnel Project, Strabag A.G. purchased a new Robbins High Performance (HP) Main Beam TBM, and a new H.P. back-up system provided by Rowa Tunnel Logistics A.G. of Wangen, Switzerland. The TBM Model 471-316, nicknamed "Big Becky," is the world's largest hard rock TBM ever manufactured. Design of the HP machine included the use of 20" rear mounted cutters, high cutterhead power and state-of-the-art ground support equipment. For ground support, a rotary-type ring beam erector was provided in the L1 area directly behind the TBM cutterhead support. The erector could hydraulically lift the ring beam or channel section into place and hydraulically expand the steel sections against the rock. Also in the L1 area, a dual-function wire mesh erector and material handling cart was provided, as well as two Atlas Copco rock drills installed on 6 m slides. A shotcrete robot supplied by Rowa/Meyco was also supplied in the L1 area that could cover a 180-degree section of the tunnel crown at a rate of 20 cubic meters per hour. In the L-2 area on the back-up, another two drills were provided as well as two more remote-controlled shotcrete robots with 360-degree coverage.

Shield Characteristics		Cutterhead	
Machine Length	45 m	Nominal cutterhead diameter	14,44 m
Back-up length	105 m	Maximal cutterhead diameter (overcut on diameter)	
Minimal shield diameter		Number and Diameter of cutterdisks	85 no and 20/17"
Shield conicity on the diameter		Total Power	4722 KW
Nominal top void		Maximal Torque	18.8 (at 2.4 rpm) MNm
Maximal top void		Torque at maximal speed	9.025 (at 5.0 rpm) MNm
		Breakaway Torque	
Thrust			
Cutterhead Thrust	19 MN	Nb of Grippers	2
Maximum Cutterhead Thrust	28 MN	Grippers Thrust	
		Stress Thrust	21
		Auxiliary Thrust	
SUPPORT		FINAL LINING	
Behind the tunnel face (installation distance)	5 m	Precast segments	
Ribs erector	steel channels	Number of segments	6 + 1 (key stone)
Sprayed Concrete Robots	one, top 180 degrees	Inner Diameter	8,7 m
Bolts Rigs	rock bolts up to 6 m long	Segment Thickness	40 cm
Other support	wire mesh 50 mm thick	Ring Length	1,5 m
		Different type of segments	1 u

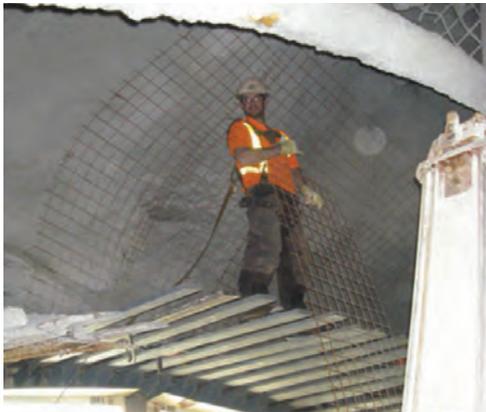
Over-break above the TBM

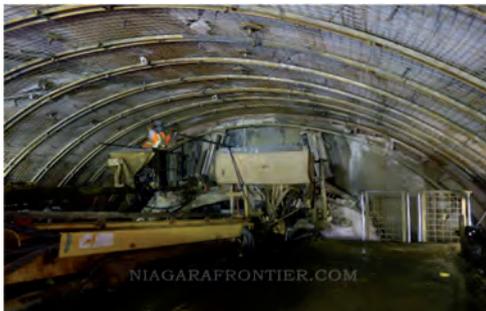
The revised ground support system.

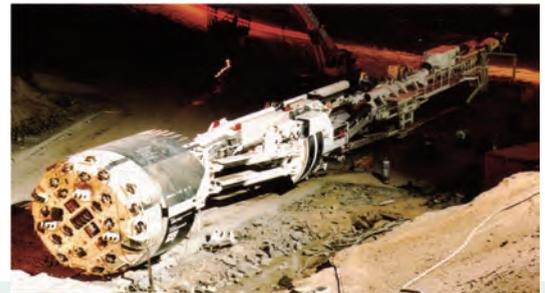
Based on the geological conditions in the water transfer and South Delivery Tunnels, it was clear the TBMs should be open-type machines. The first of the Robbins machines, the -206, was rebuilt by Harrison Western Corp and shipped to the jobsite in 1991. A Jarva (Kelly type) MK 15 machine followed that, along with two identical open-type machines, the -266 and -267. The machines were supplied with back-loading cutterheads and could be used with either 432 or 483 mm diameter discs. The 483 mm diameter cutters could achieve a cutter load of 312 kN for difficult ground where increased power might be needed. The machines offered flexible ground support options--on the -266/-267 machines a probe drill mounted on a 7 m long sliding deck about 20 m behind the cutterhead allowed for probe drilling concurrent with TBM advance. The machines were designed to be able to support the tunnel walls with a combination of rock bolts, wire mesh, and ring beams as required.

Shield Characteristics		Cutterhead	
Shield Length		Nominal cutterhead diameter	5.18/5.0/5.0 m
Back-up length		Maximal cutterhead diameter (overcut on diameter)	
Minimal shield diameter		Number and Diameter of cutterdiscs	37 no. 17», 34 no. 17», 31 no. 17» or 19» m
Shield conicity on the diameter		Total Power	1110/1680/1575
Nominal top void		Maximal Torque	1.336/1.588/1.475
Maximal top void		Torque at maximal speed	
		Breakaway Torque	
Thrust			
Cutterhead Thrust	7.4/8.3/9.7 MN	Nb of Grippers	2/4/2
Maximum Cutterhead Thrust		Grippers Thrust	
		Stress Thrust	
		Auxiliary Thrust	
SUPPORT		FINAL LINING	
Behind the tunnel face (installation distance)		Precast segments	
Ribs erector	steel channels	Number of segments	
Sprayed Concrete Robots	yes, in difficult ground	Inner Diameter	
Bolts Rigs	systematic rock bolts	Segment Thickness	
Other support	wire mesh	Ring Length	
On the back up		Different type of segments	
Ribs erector		Steel ratio reinforcement

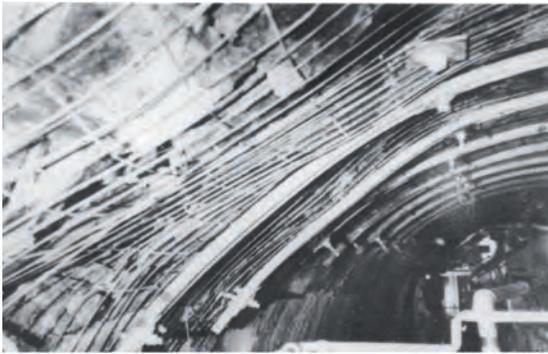
Cracking of basalt in transfer tunnel

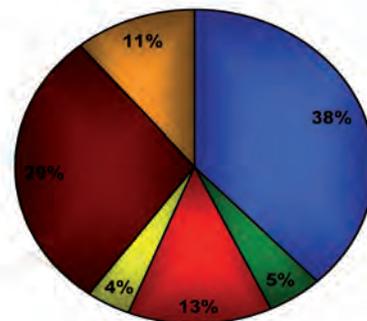
Water Transfer Tunnel Main Beam -267

- Boring/Regripping
- Cutter Changes/Inspections
- TBM Maintenance/Breakdown
- Delay Time Due to Back-up System
- Delay Time Due to Job Site
- Delay Time Due to Rock Support
