Refurbishment of the Amsterdam IJtunnel

ITA COSUF Workshop Safety versus Economics, Cost-efficiency of tunnel safety measures

Bart Duijvestijn - Rome, 22 June 2012

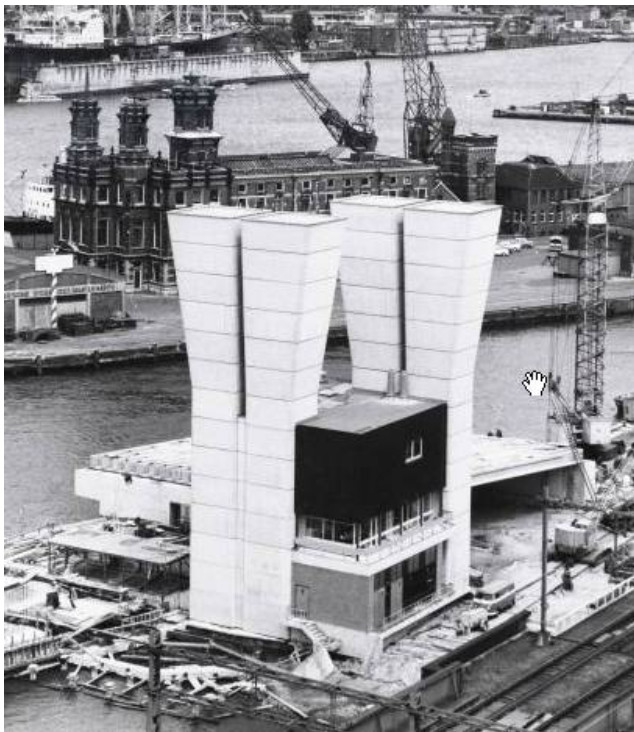
Characteristics of the IJtunnel

- Length 1,040 m (original length)
- 2 tubes, each 4.30 m * 9.21 m
- Maximum speed 70 km/h (original)
- Transverse ventilation system

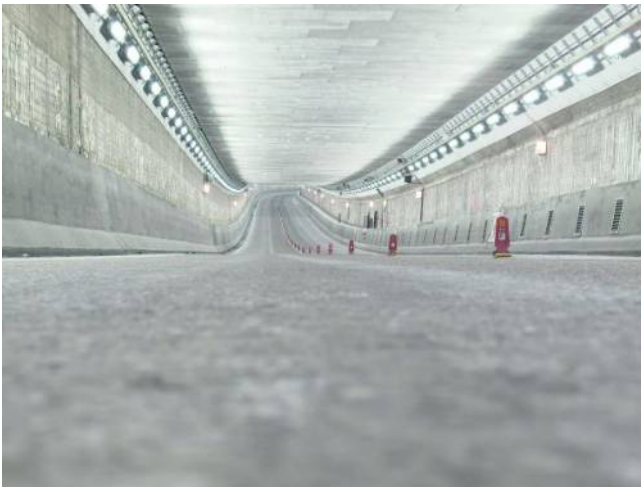
Tunnel lighting

- It is not necessary to replace armatures in the tunnel
- In the central zone calculations show that led lighting is possible

➔ Existing armatures are changed, TL-lighting is replaced by led.

A direct cost saver due to less use of electricity, a decrease of 59% CO₂

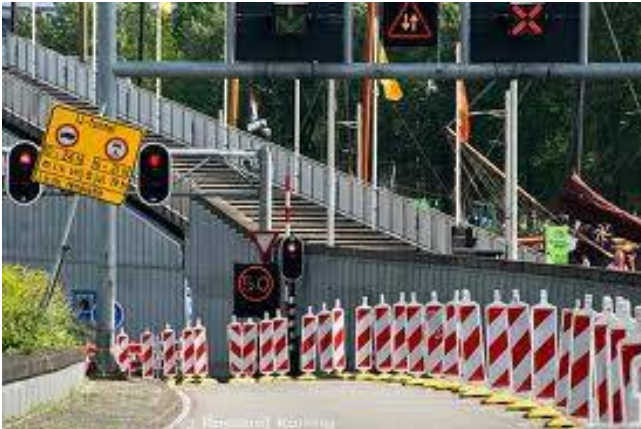
Operating during the refurbishment

Extra safety measures are taken:

- Flexible poles to separate the lanes in opposite direction
- Gating of busses
- Instruction to bus drivers (professional drivers)
