An Independent View of the Pinheiros Station Accident (Sao Paulo Metro) and Lessons Learnt for Future Contractual Arrangements

J.M. Barros (IPT)

A.P. Assis (UnB)

ITA World Tunnel Congress, Agra, India – 19-25/09/2008

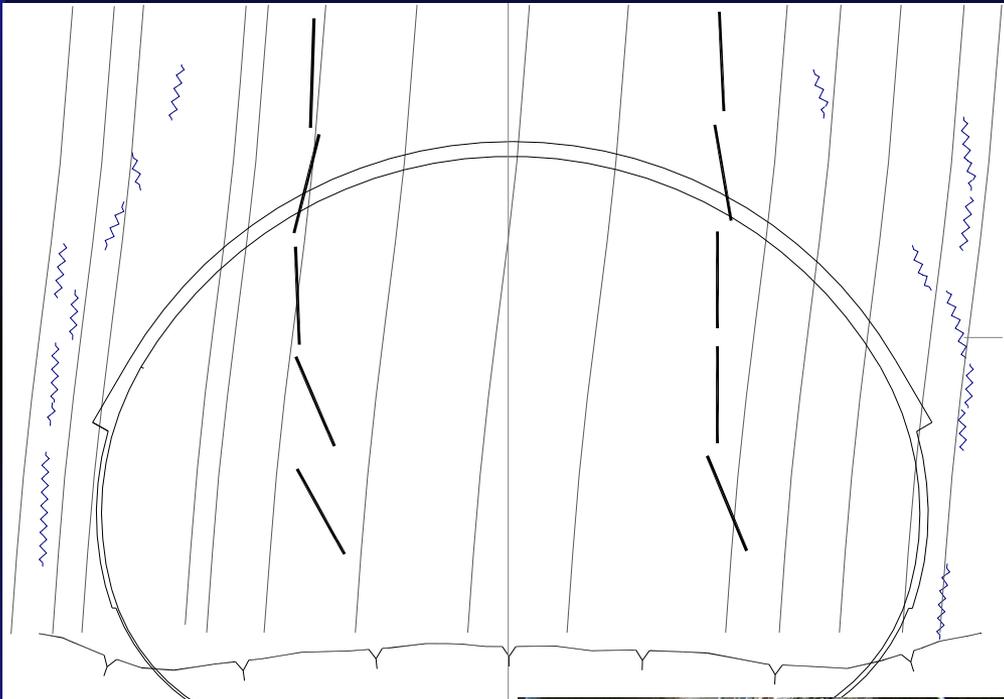
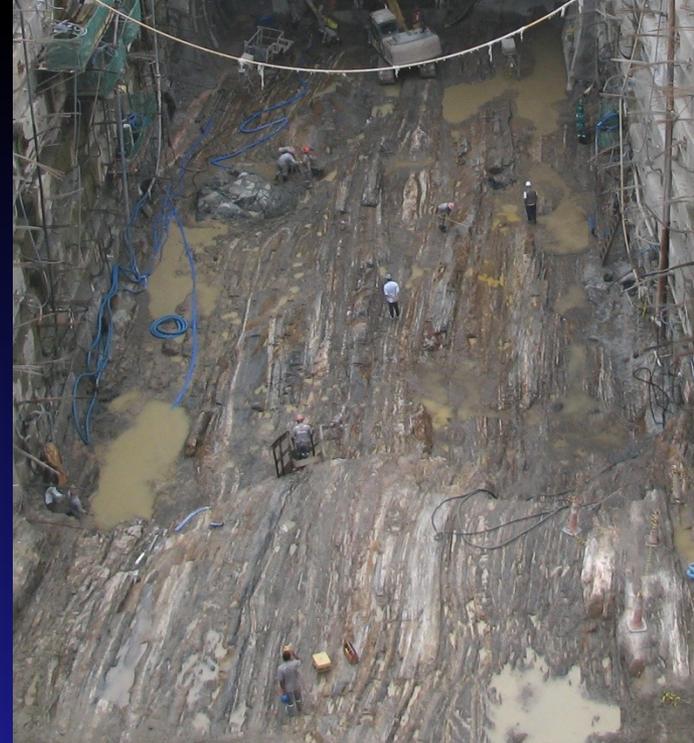
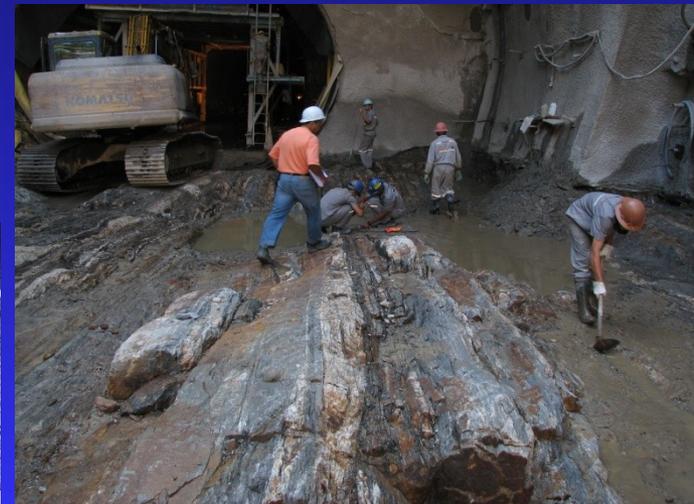
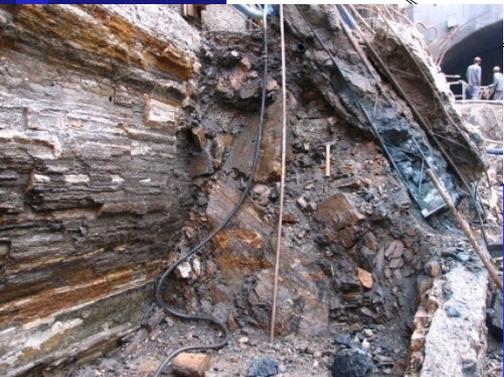
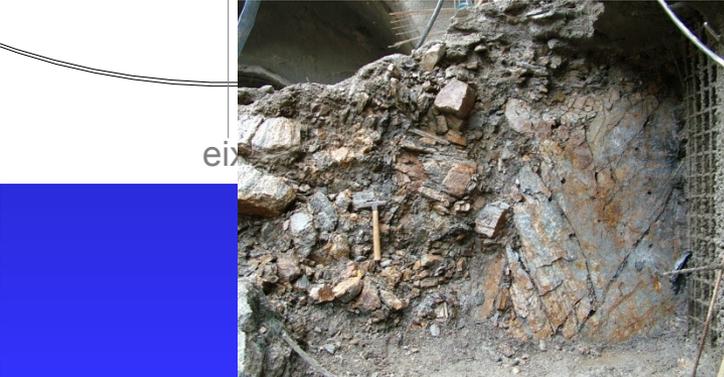
Main Report Findings: Collapse Evidences

Instrument	Position	Forecasted (mm)	Observed on 11/01/07 (mm)	Observed / Forecasted
Extensometer	Axis	-0,7	-11	17
	Lateral Wall	-0,7	-12	19
Convergence Pins (Settlement)	Axis	-0,7	-7	10
	Upper	-0,9	-20	22
	Lower	-0,5	-7	13
Convergence	△ P2-P3	-0,2	-21	95

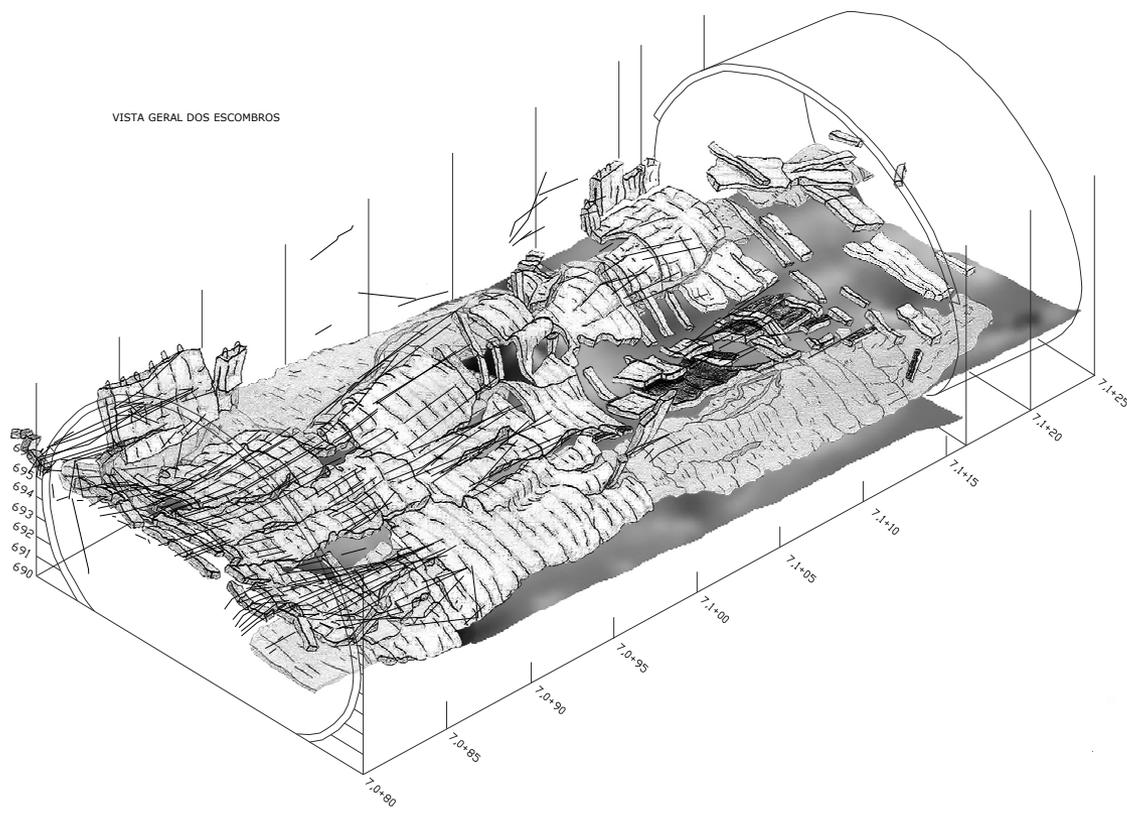
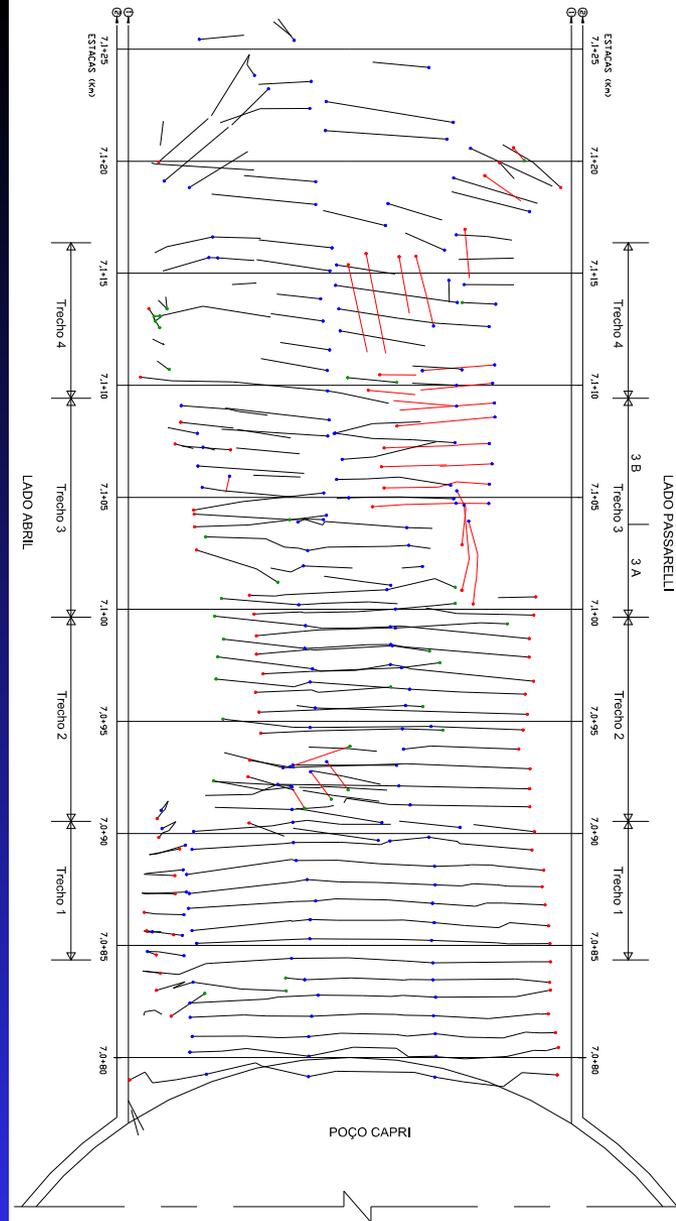
Main Report Findings: Collapse Evidences

Instrumentation evidences

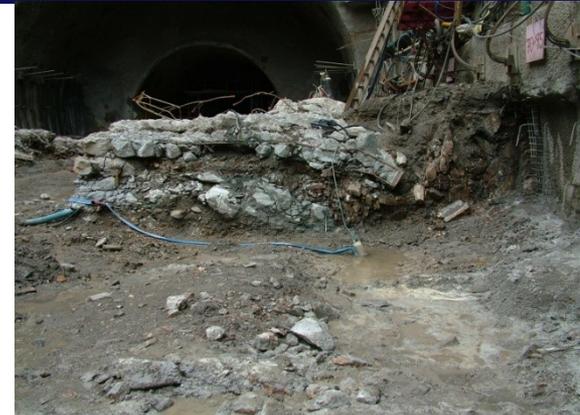
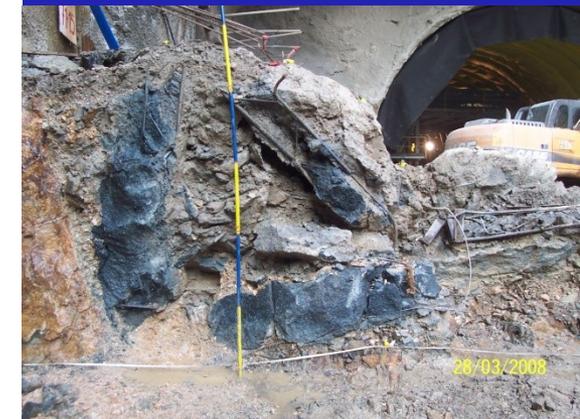
Main Report Findings: Collapse Evidences

■ Debris position evidences
