# Report on the Damaging Effects of Water on Tunnels During Their Working Life

## ITA Working Group on Maintenance and Repair of Underground Structures

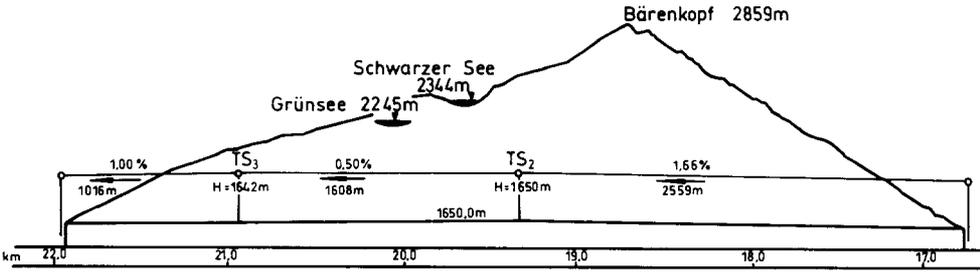
<p style="text-align: center;">Fig. A1/1: Profile of the Felbertauern Tunnel</p>

<b>GEOLOGICAL AND HYDROLOGICAL CONDITIONS:</b>	The tunnel is driven through gneiss, amphibolite and green slate.	
<b>NATURE OF INFLOW:</b>	<ul style="list-style-type: none"> <li>• Leakage appeared at all ring joints near both portals.</li> <li>• Many wet surface areas were registered near those places, at which soil water was collected by the Oberhasli method (due to clogged tubes).</li> <li>• Leakage appeared at construction joints of the ceiling slab.</li> <li>• The water is not aggressive.</li> </ul>

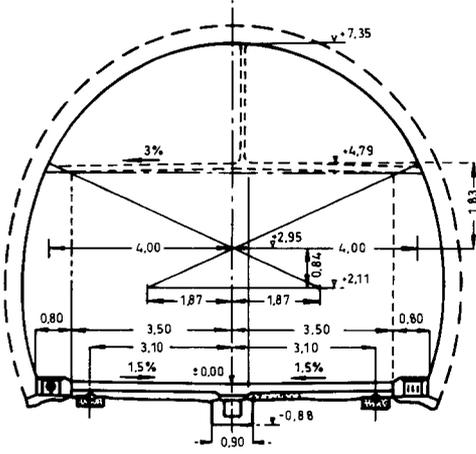
<p style="text-align: center;">Fig. A1/2: Cross-section of the Felbertauern Tunnel</p>	
<b>NATURE OF LINING:</b>	Lining (40 cm thick) consists of concrete (without reinforcement) with a compressive strength of 30 N/sq. mm; block length, 13.5 m; block joints without sealing. Soil water was collected by the Oberhasli method and flows to the bottom drain, which has inspection chambers every 100 m. Ceiling slab (13 cm thick) is made of reinforced concrete.

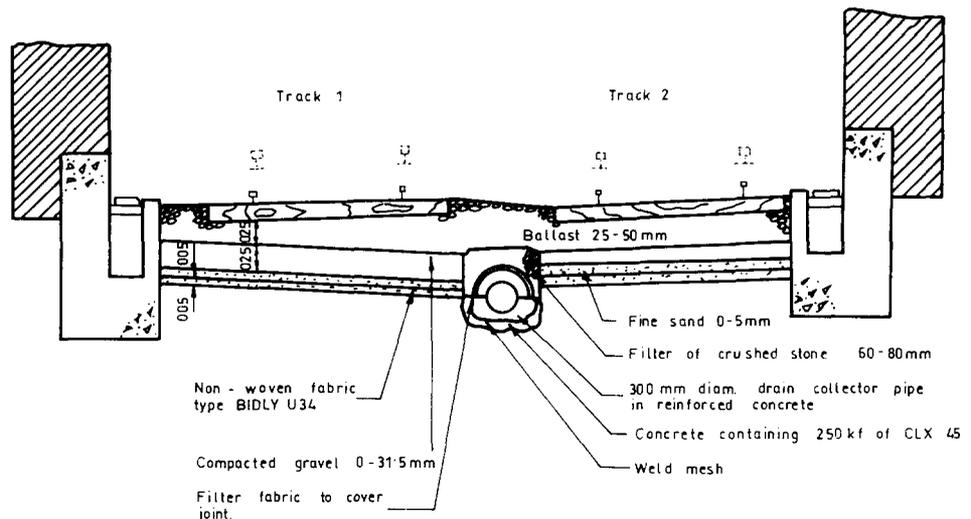
Fig. F2/3 PAGNY SUR MEUSE TUNNEL  
TRACK BED DRAINAGE BLANKET  
(Light type)

- For the walls and track bed:
  - Underpinning of walls to mitigate the effects of their disturbance and to allow reconstruction of the track bed while providing the clearances required for a maximum speed of 140 km/h;
  - Achievement of a flexible reconstruction after lowering of the track bed..

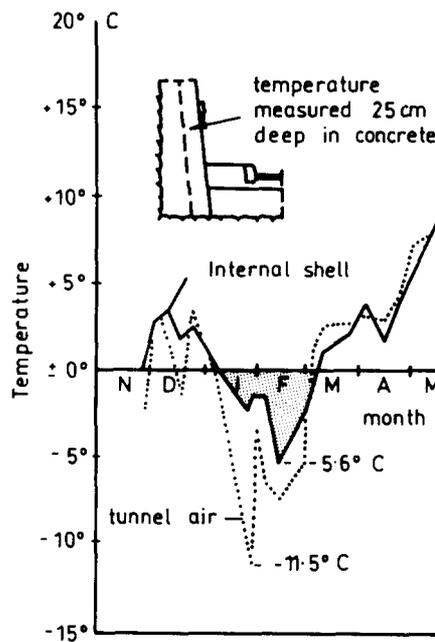
Fig. CH4/3. Temperature measurement results of the tunnel air and 25 cm deep in the lining between 10. 1985 and 5. 1986.
